Jeff's Consulting Services LLC

Property Inspection Report

Client(s): **Sample Client**
Property address: **123 Main Streetytown USA**
Inspection date: **Friday, January 21, 2022**

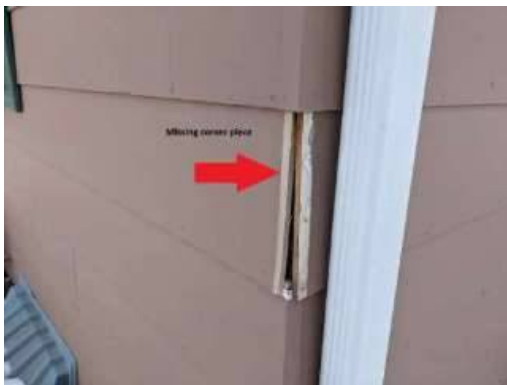
Photo 1-1

Some sections of siding and/or trim were missing. Recommend that a qualified person repair, replace or install siding or trim as necessary.

One piece of corner flashing missing on Northeast corner of house. Other pieces of corner flashing appear loose. Caulking in a couple of areas, exterior door trim and corners is separated.

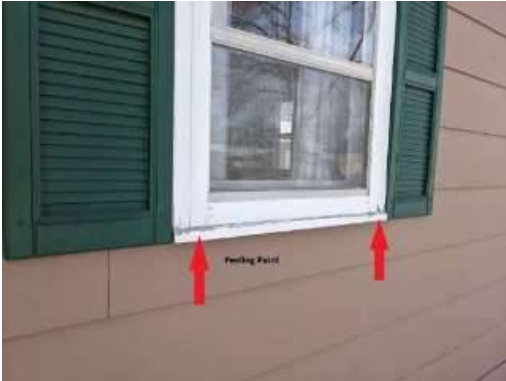
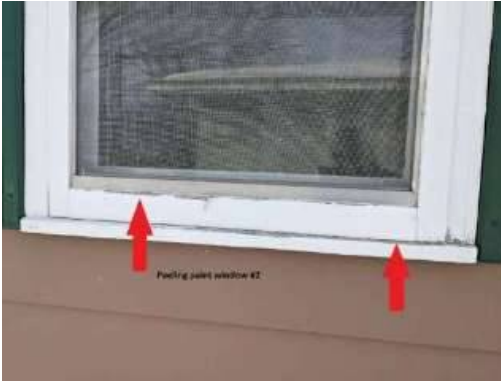
The paint in some areas was failing (e.g. peeling, faded, worn, thinning). Siding and trim with a failing finish can be damaged by moisture. Recommend that a qualified contractor prep (e.g. clean, scrape, sand, prime, caulk) and repaint where necessary and per standard building practices. Any repairs needed to the siding or trim should be made prior to this.

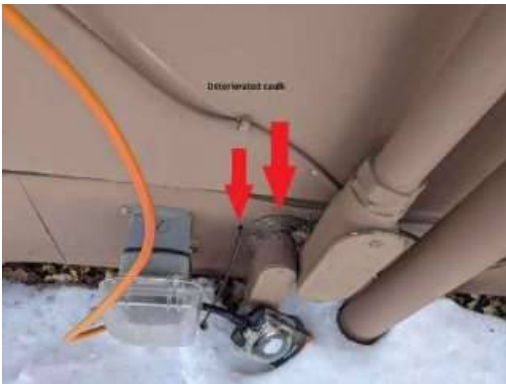
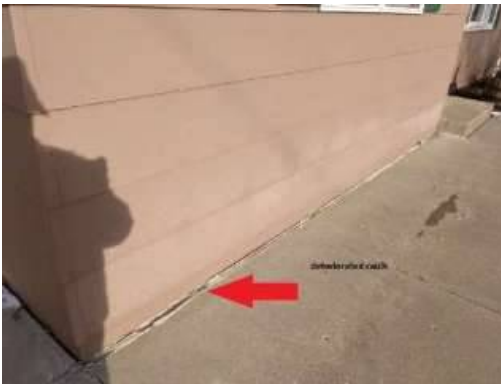
Caulk was deteriorated in some areas. For example, around doors, at siding butt joints and/or at wall penetrations. Recommend that a qualified person renew or install caulk as necessary. Where gaps are wider than 1/4 inch, an appropriate material other than caulk should be used. For more information, visit: <https://www.reporthost.com/?CAULK>

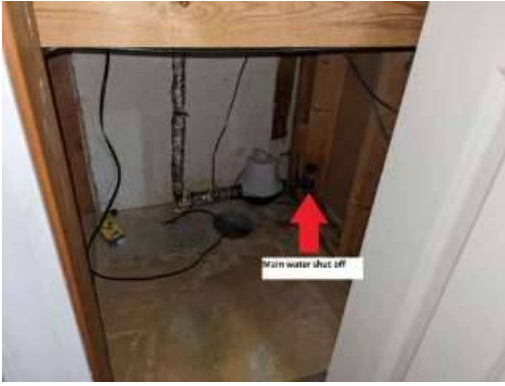
Photo 5-1

Water Shut off for house.

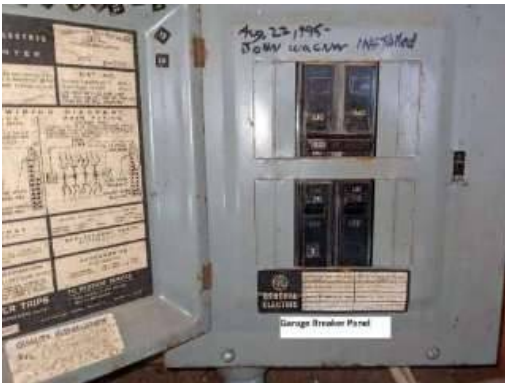
Photo 6-1

Electrical service in garage.

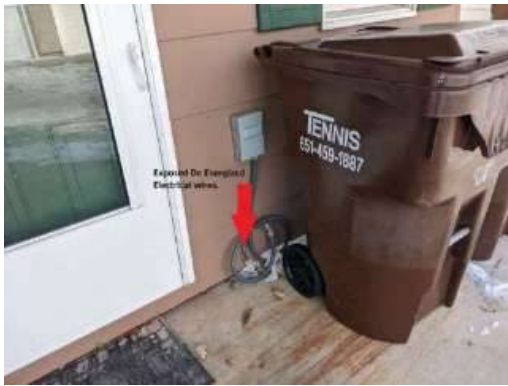
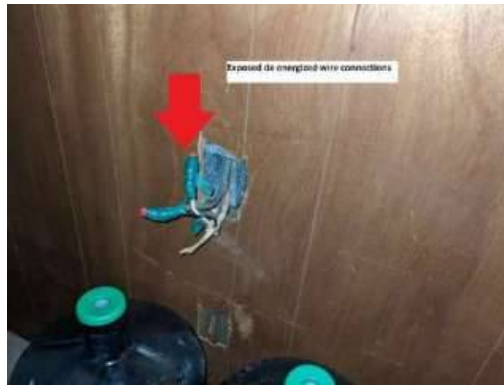
Wire splices were exposed and were not contained within a covered junction box. Outlet box in back storage had wire splices outside of junction box. Wires did not appear to be energized. Outside service disconnect panel at northwest corner of house has wires capped with wire nuts exposed. The panel appeared to be switched off.

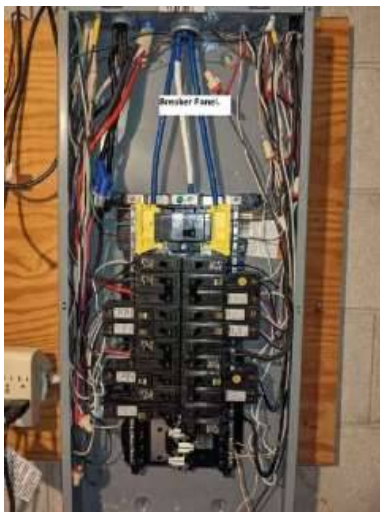
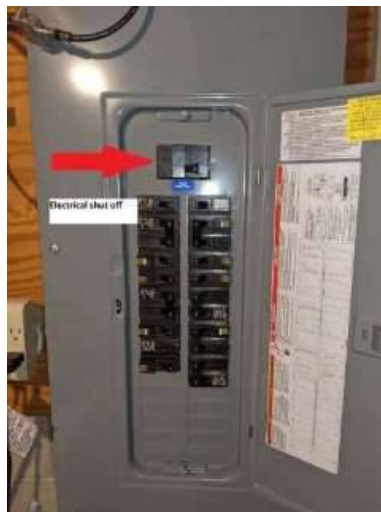
Electrical power shut off

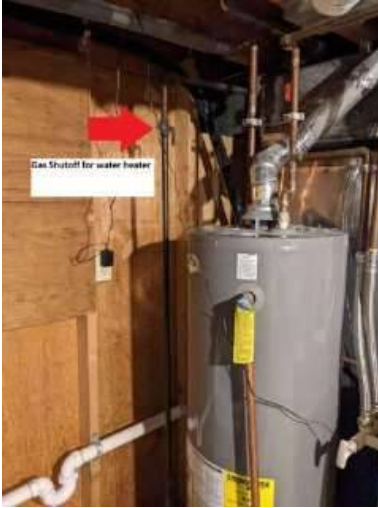
Photo 10-1

10) **i** Gas Shut off for water heater.

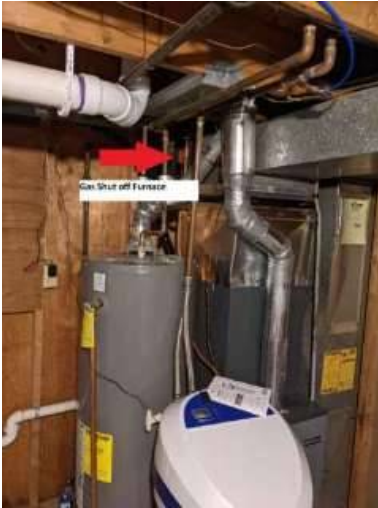
Photo 12-1

12) **i** Gas shut locations for Furnace.

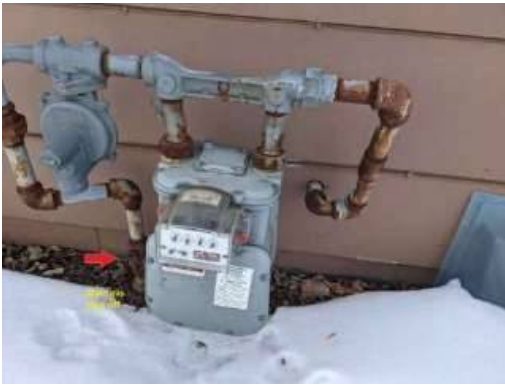
Photo 13-1

13) **i** Main gas shut off location.

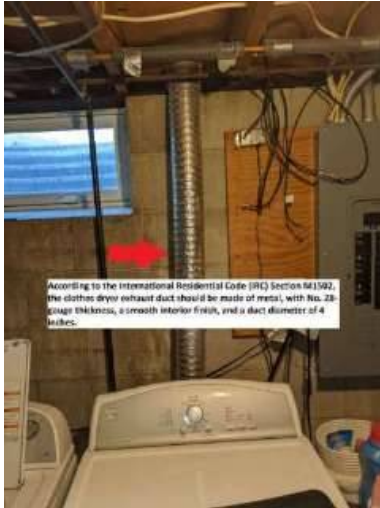
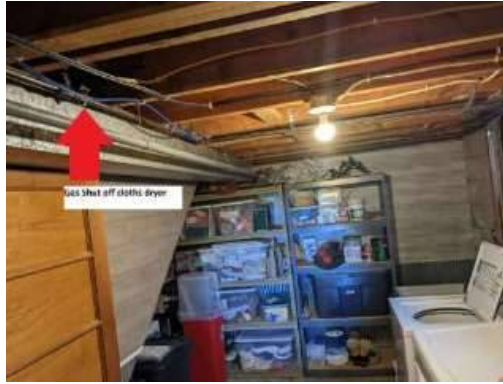
14) **+** The clothes dryer was equipped with a vinyl or mylar, accordion-type, flexible exhaust duct. The U.S. Consumer Product Safety Commission considers these types of ducts to be unsafe, and a fire hazard. They can trap lint and are susceptible to kinks or crushing, which can greatly reduce the air flow and cause overheating. Recommend that such ducts be replaced with a rigid or corrugated semi-rigid metal duct, and by a qualified contractor if

I was unable to determine if this duct is UL2158A listed and marked for safe dryer venting.

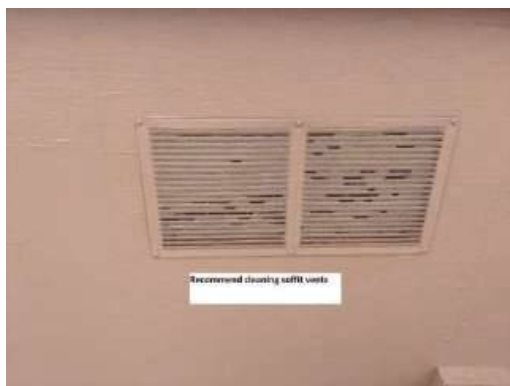
Photo 15-1

Soffit vents should be cleaned of dust.
